ST. JOSEPHS LAKE DAM

SULLIVAN COUNTY, NEW YORK
INVENTORY No. NY 324

PHASE I INSPECTION REPORT NATIONAL DAM SAFETY PROGRAM

Name of Dam:	St. Josephs Lake Dam (I.D. No. NY 324)
State Located:	New York
County Located:	Sullivan
Stream:	Black Brook (tributary of Mongaup River)
Date of Inspection:	October 20, 1978

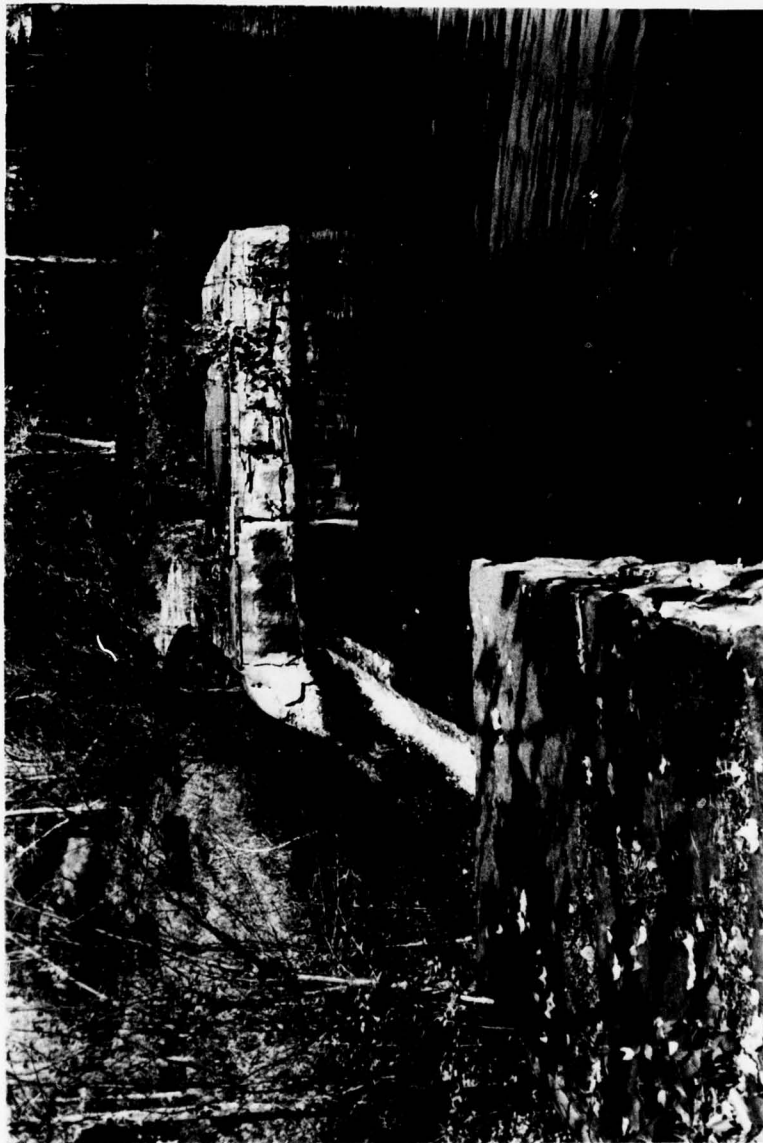
Overview of St. Josephs Lake Dam
Looking North

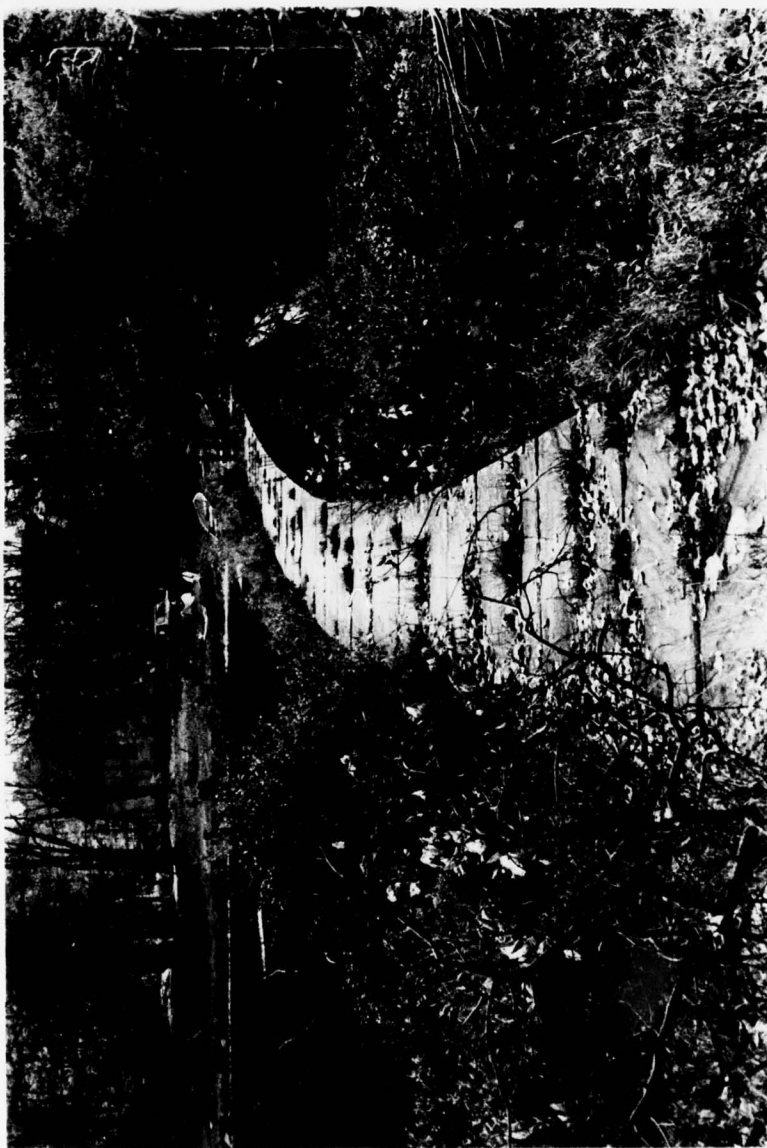
Overview of St. Josephs Lake Dam
Looking South

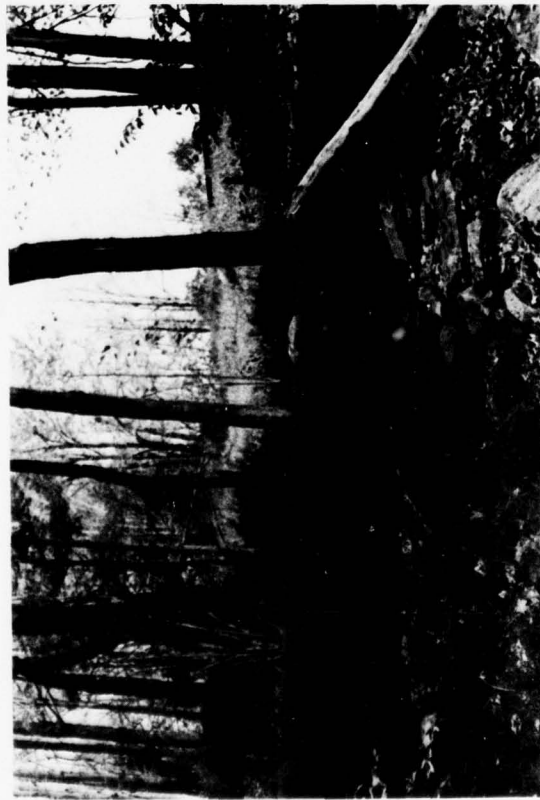
Photo #1
 Earth Embankment & Abandoned Hydroelectric Supply Conduit
 Looking East

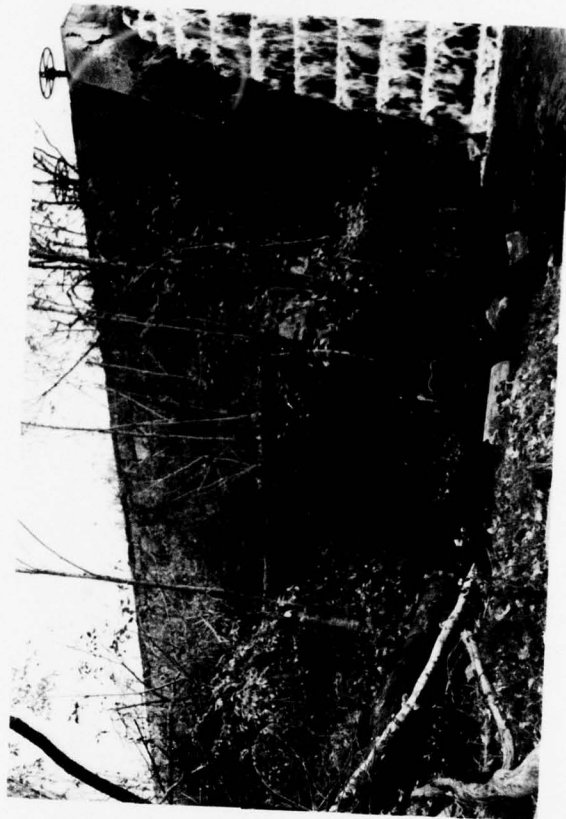
Photo #2
 Earth Embankment & Low Level Outlets
 Looking East

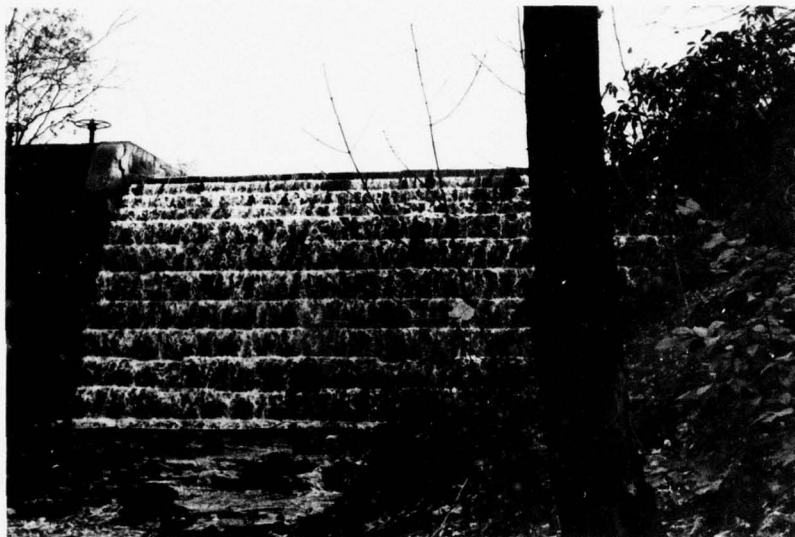
Photo #3

The spillway is constructed of stepped sandstone masonry blocks of varying heights forming somewhat of an ogee shape. Flow over the spillway prohibited complete inspection of the spillway surfaces and the immediate downstream area. Two concrete buttresses form the north and south extremities of the spillway. The top of the buttress is 2.5 feet above the spillway crest. The buttresses are severely deteriorated, however, little seepage from the spillway discharge was evident flowing through the buttresses. The crest is composed of 6 feet long and 3 feet wide masonry blocks; the joints of which are deteriorated and require recaulking. The tailrace channel is generally flat and wide, relatively free of debris with some riprap lining. Some large trees are present in the downstream channel. The area directly below the spillway appears to be eroded from the spillway discharge, to a width of 6 feet on the south side and a width of 10 feet on the north side. The depth could not be determined due to spillway discharge.

Spillway, Looking East

4. Investigation of the spillway when the reservoir is drawn down to observe the condition of the spillway and also the erosion area at its base. The NYS Department of Environmental Conservation, Dam Safety Section will be available to assist in this investigation (Tel: (518) 457-6310).

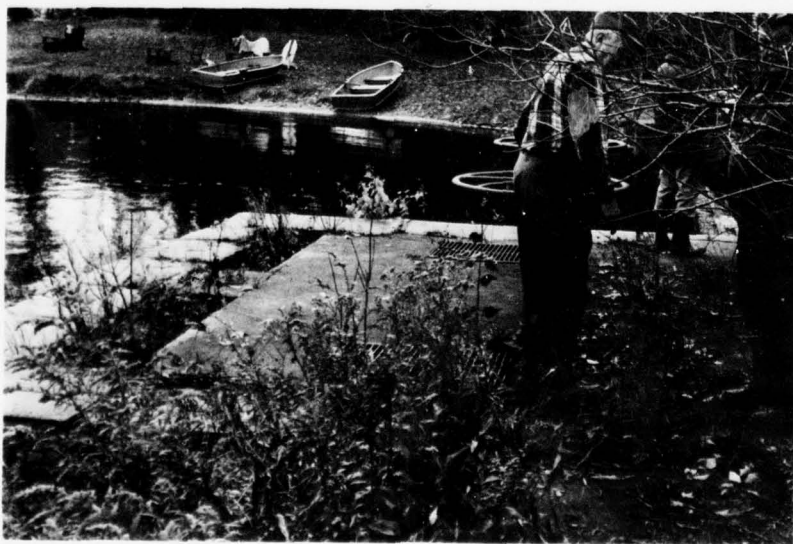
Photo #4

Gate Valve Platform, Looking South

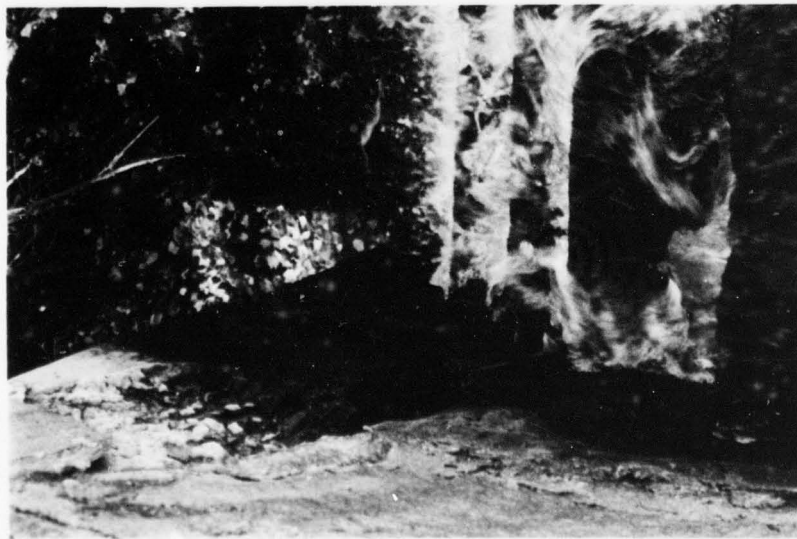
The sandstone block masonry structure is generally in good condition, except the mortar of the joints has deteriorated substantially. The areas of primary concern are to joints at the spillway crest and the area south of the spillway where seepage was observed. Considerable moss growth approximately 10 feet south of the spillway and 2 feet below the lake level was evident. Adjacent to the moss area (approximately 3 feet south of the spillway) seepage was flowing through the joints at a rate of 2 to 5 gallons per minute. This flow appeared to be related solely to the joint deterioration and should be easily controlled by repointing the area (see photograph # 7). The concrete buttresses located at each end of the spillway have extensively cracked and spalled. The south buttress deterioration has progressed so far that a void near the spillway crest exists through the entire width of the buttress (see photograph # 5 & 8).

Photo #5
South Spillway Buttress
Looking West and Down at Spillway

- b. Structural Cracking cracked and spalled buttresses located
at each end of the spillway - they have been repaired
in the past but have deteriorated again - south buttress, could
see thru buttress because crack was so large, near top of spillway

- c. The mortar joints of the masonry blocks at the spillway crest and adjacent to the spillway on the south downstream face require re-pointing.
- d. The spillway buttresses require repair to prevent further deterioration.

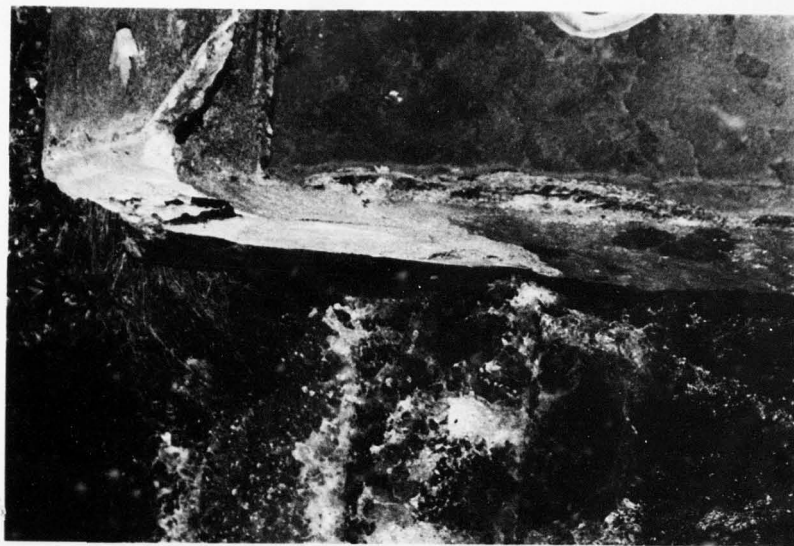
Photo #6
North Spillway Buttress
Looking West and Down at Spillway

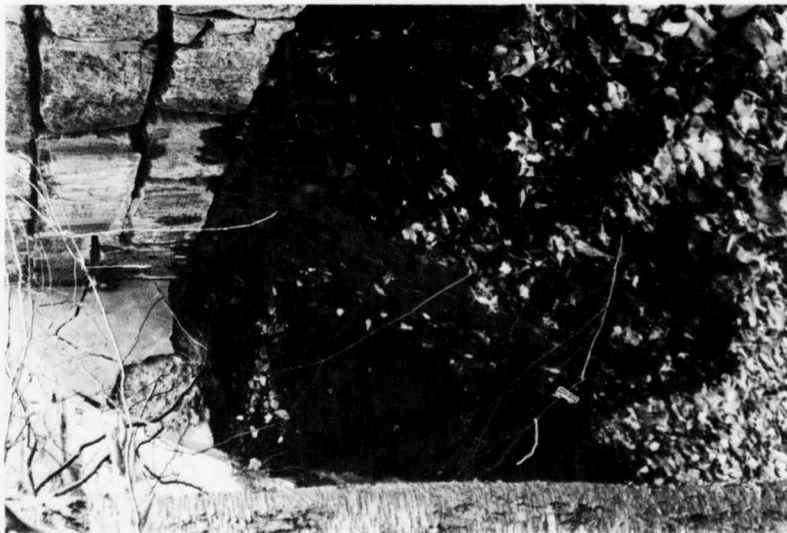
Photo #7
Downstream Face of Masonry Section, South of Spillway
(Looking North) Note Seepage

- f. Water passages, conduits, sluices _____
operational - conduit for facility power
generation is now abandoned
- g. Seepage or Leakage considerable moss growth south of south buttress
on downstream face \approx 2' below water line - seepage observed in this
area (estimated 2-5 gpm) seeping thru deteriorated joints in masonry
blocks - principle area of seepage from buttress to 3 feet south.
Additional slight seepage to 10 feet south of buttress

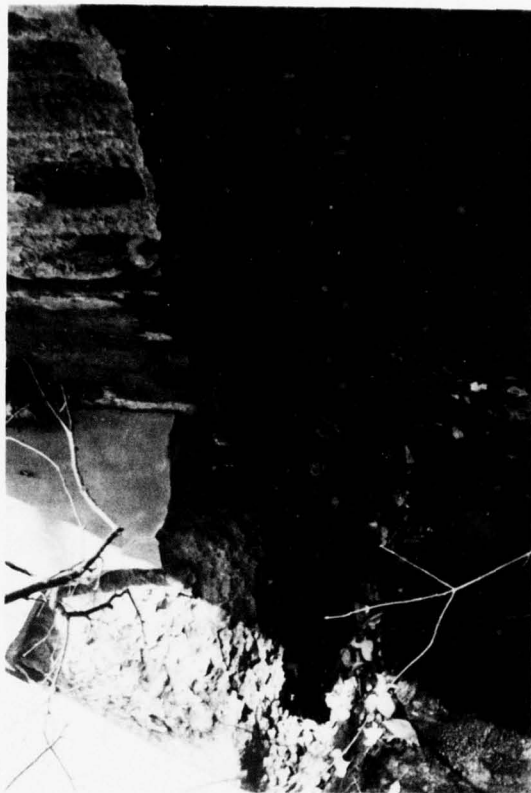
Photo #8
Close up of Seepage Area
and Deteriorated Buttress

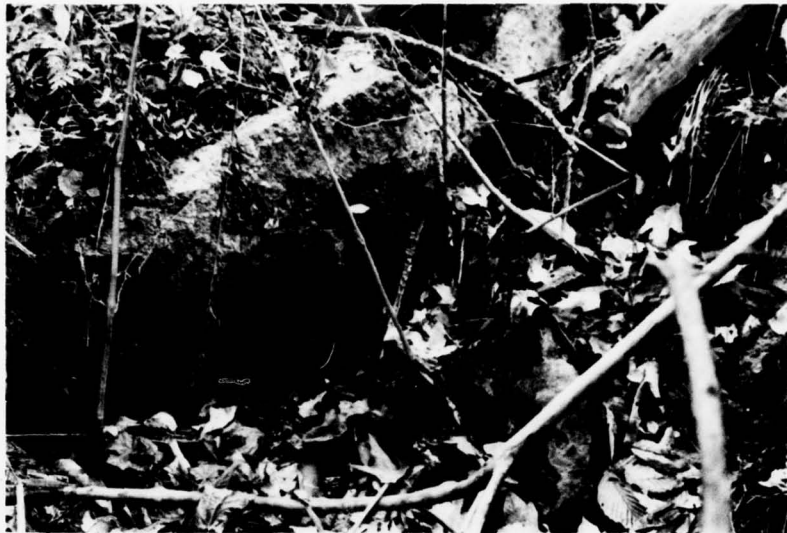
Photo #9

Seepage Area of Earth Embankment Adjacent to Low Level Outlets
and above Photo #10, Note Seepage at Base of Rock

(5) Seepage 3 locations observed in the earth embankment where seepage
was evident - located near the outlet conduits - flow 5 to 10

3. Investigations of the observed seepage in the earth embankment and the masonry portion of the dam are required to determine the type and extent of remedial measures warranted. The investigation should include periodic and systematic observations and measurements of the quantity of seepage.

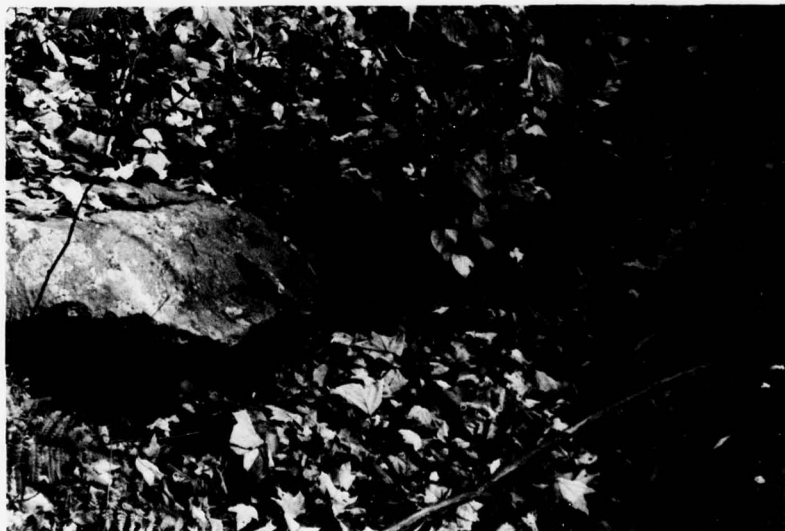
Photo #10

Seepage Area of Earth Embankment Adjacent
to Hydroelectric Supply Conduit and below Photo #9
Note Seepage between Boulders in photo center

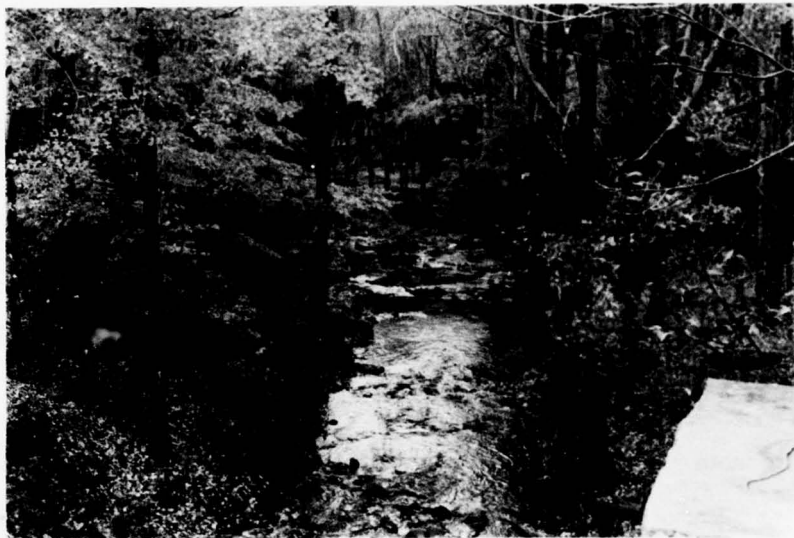
Photo #11

Downstream Channel as Viewed from Spillway
Looking West

d. Condition of Tail race channel PIPRAP ON CHANNEL, CHANNEL FAIRLY
FLAT AND WIDE, RELATIVELY FREE FROM DEBRIS AND
DOESNOT APPEAR TO HAVE ANY POTENTIAL PROBLEM.
some large trees on banks of channel
